Problems and Recommendations for Repair

Exterior

Interior

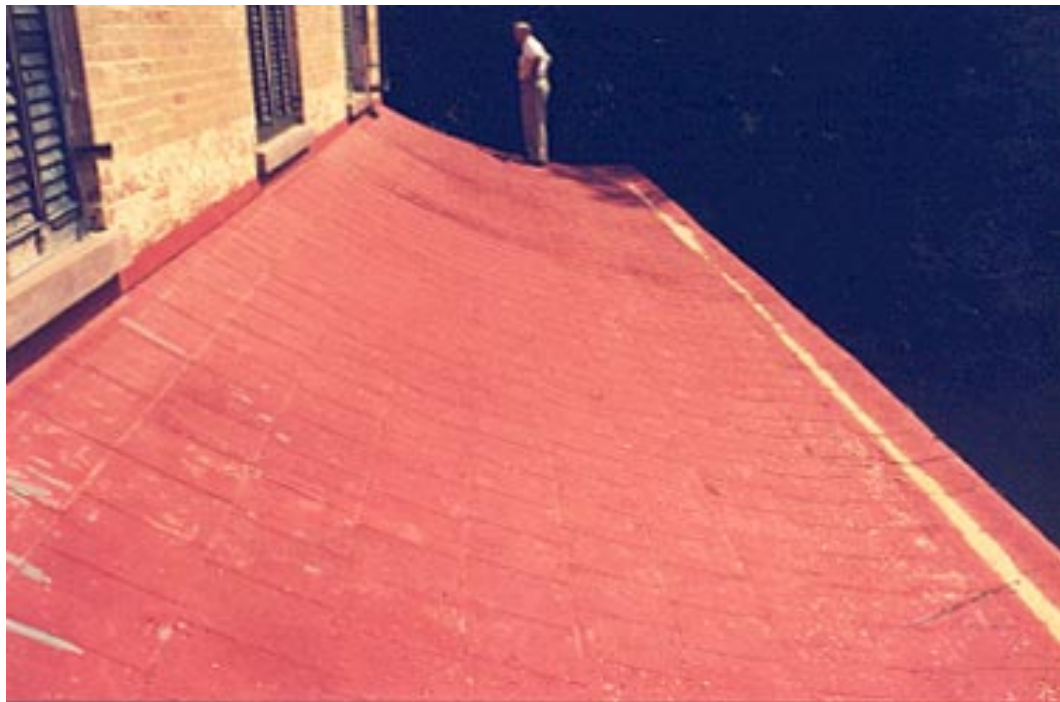
Terne- or tin-coated roof of west verandah. Peeling paint leaves the metal vulnerable to the elements allowing for deterioration.

Similarly, the metal roof over the west verandah is in surprisingly good condition. It should be stripped of all paint and repainted. The roof owes its longevity to the paint coatings it has continuously received, and it is expected that new paint will protect the roof into the foreseeable future. The built-in gutter along the eaves should be replaced, if possible, without disturbing the remainder of the roof.

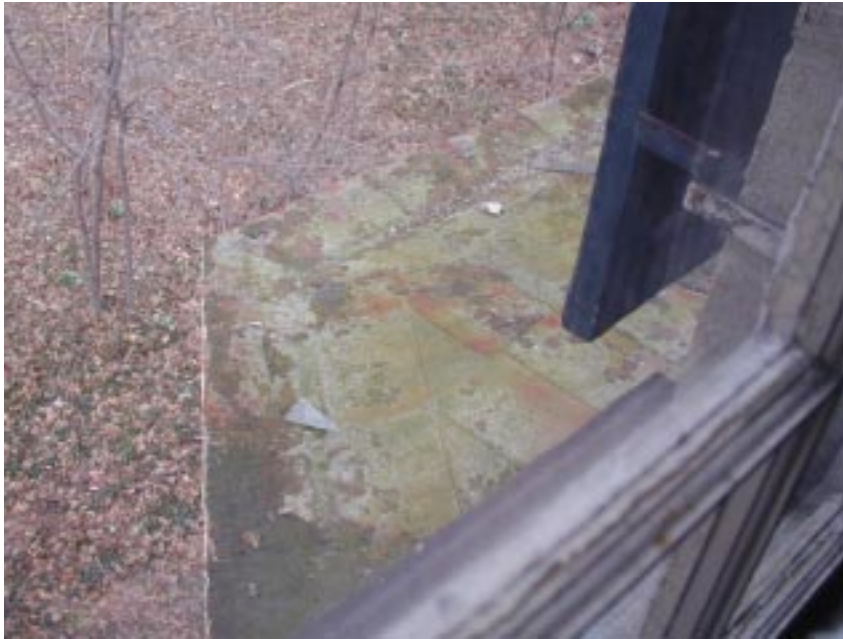
Biological growth and rust are enemies to the roof of the north bay window. It is constructed of the same material as the west verandah roof, therefore, the metal should be carefully brushed and repainted.

The metal roof of the bay window on the north end of the north wing is in good condition. However, significant biological growth and rust will compromise the roofing material if it is not repaired. The roof should be stripped of all paint, rust and algae and repainted. Care must be taken, when removing paint, not to scratch or abrade the tin coating protecting the iron.

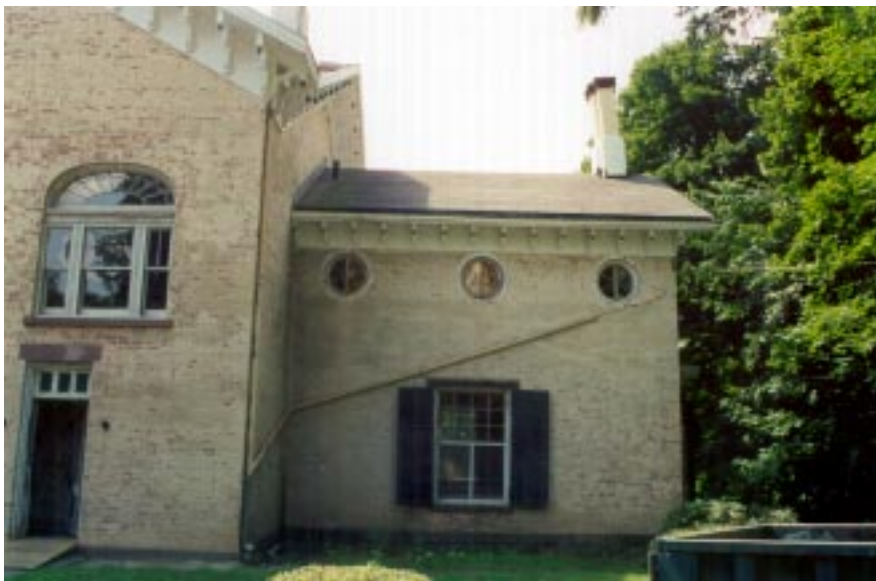
Leader traversing the rear wall of north wing carries water from the roof of the north wing to a common exit point. The leader should be re-routed directly down the wall of the north wing and the water issued away from the house. After the brick masonry is repaired, the house should be painted as well as the leaders.

As part of the roofing system, the gutters and leaders should be examined for defects and repaired or replaced as necessary. All of the downspouts on the main roof and the west verandah roof are badly deteriorated and require replacement. They should be replaced with similarly sized pipes at the same locations, however, the pipes should be paintedterne-coated stainless steel. For the near future, the pipes can continue to issue water out at grade away from the house, however, the best long term solution would be to install a sub-grade drain system for the roof water. The extension of the system will keep roof water from entering the basement.

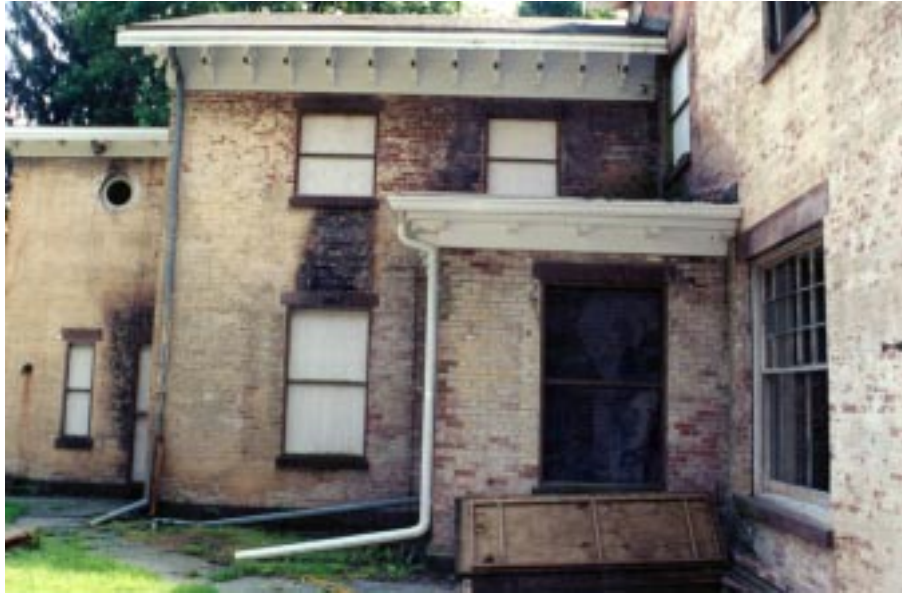
View of the service wing from the north (the Pantry is the small one-story structure to the front of the grouping). The existing leader system allows water to seep into the basement. The walls of the one-story room are dilapidated and must be dismantled and rebuilt. Note the charred brick around the window and door openings.

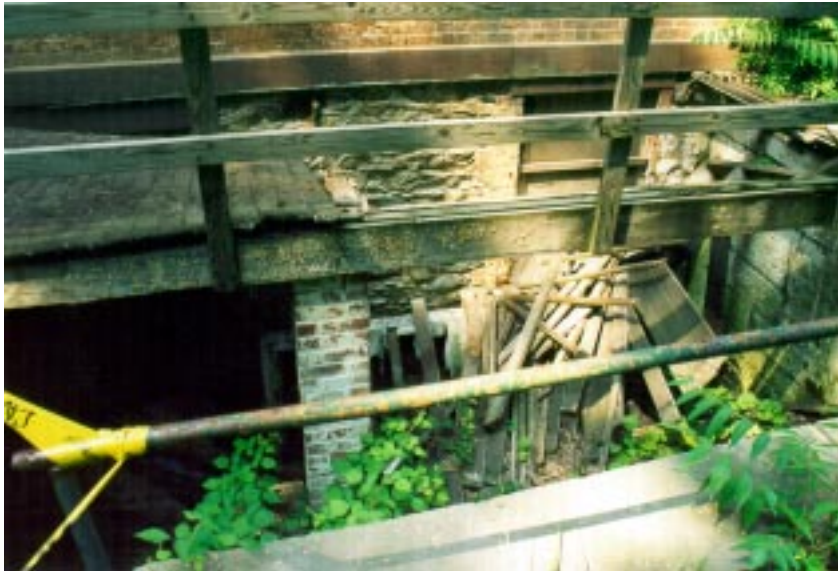
Similarly, the retaining walls at the south areaway to the cellar are collapsing along the south. The wall must be disassembled and reconstructed as well. Several courses of stone have raised the retaining wall to accommodate the higher grade around the house, and may have contributed to the problems found at this location. Handicap access will be facilitated via the southeast porch as the walkway will be graded up to the deck level.

Collapsing walls of the south areaway. The southeast verandah, when reconstructed will only partially cover the areaway. For the safety of the public, it should be covered.

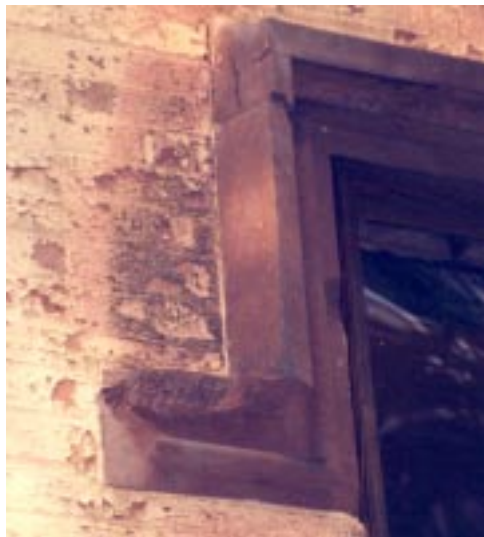
Many of the brownstone lintels and watertable stones are cracked, chipped or missing and should be restored. The quarry for the brownstone has now reopened and is in operation, therefore the stone for Dutchman repair would be available. If it cannot be obtained, it is recommended that a synthetic stone repair compound be used in the repair work matching the color and texture of the original stone. Repair work of this type has improved in recent years, and it is less costly than using real brownstone and Dutchman repairs.

Brownstone lintel on the south facade chipped during the heat of the 1985 fire. Either Dutchman or synthetic stone repair would be appropriate techniques for restoration.

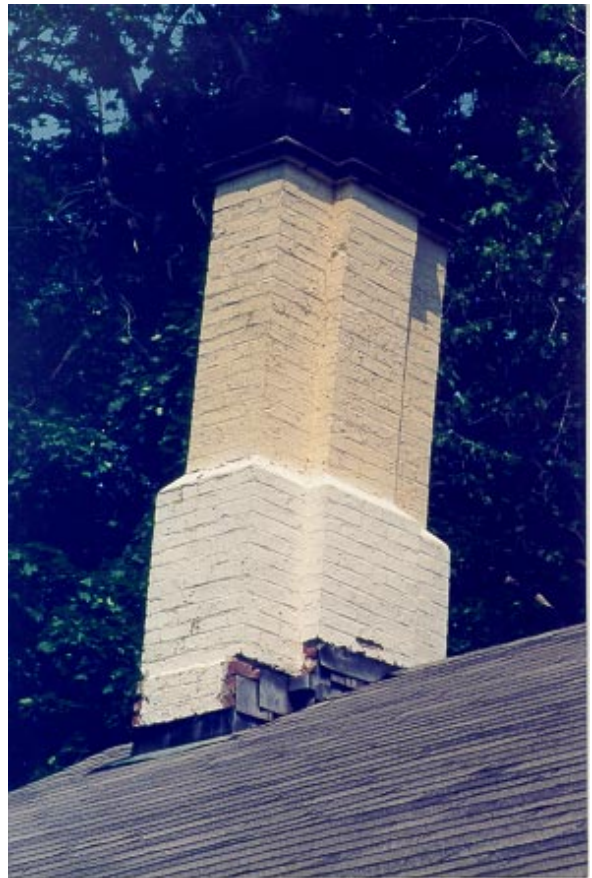
The restoration of the masonry portions of the house must include work at the chimneys. The condition of the interior of the chimneys is unknown, but at least two chimneys, the north chimney on the north wing and the northwest chimney on the main block, are noticeably leaning. The north chimney is false, corbelled out above the circular window in the gable to create a symmetrical appearance on the exterior. Strangely, the two chimneys lean in opposing directions, so there is no obvious answer as to what caused their present condition. Since photographs from the 1940s reveal these chimneys were leaning at that date, it is unlikely that they pose any threat to the fabric of the house. However, if any major restoration campaign is undertaken, the stability of these and other chimneys should be checked and disassembly and reconstruction may be required at the two chimneys mentioned.

Chimney at north wing. The tilt is quite obvious as is the failed flashing.

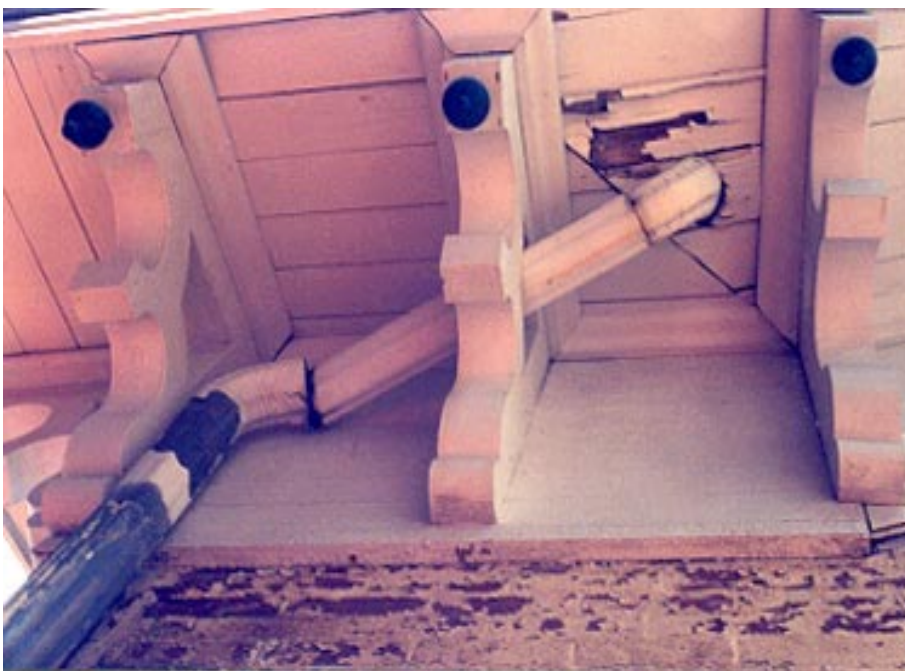
In several areas where roof leader pipes extend through the cornice, the flashing around the pipes has failed allowing water

Deterioration of wood at south-west corner of main block due to poorly flashed gutter/drainpipe connection. Note the peeling paint on the brick masonry below the cornice boards.

to penetrate into the surrounding roof deck. These areas are easily discerned because the paint has failed around the pipes. Moreover, the pipes themselves have pulled away at their connections, allowing water to flow down the surface of the house. One of the first items of work that must be performed on the house is the repair to the roof deck at all pipe penetrations, re-flashing the areas around the pipes and reassembling the pipes to prevent any further leaking.

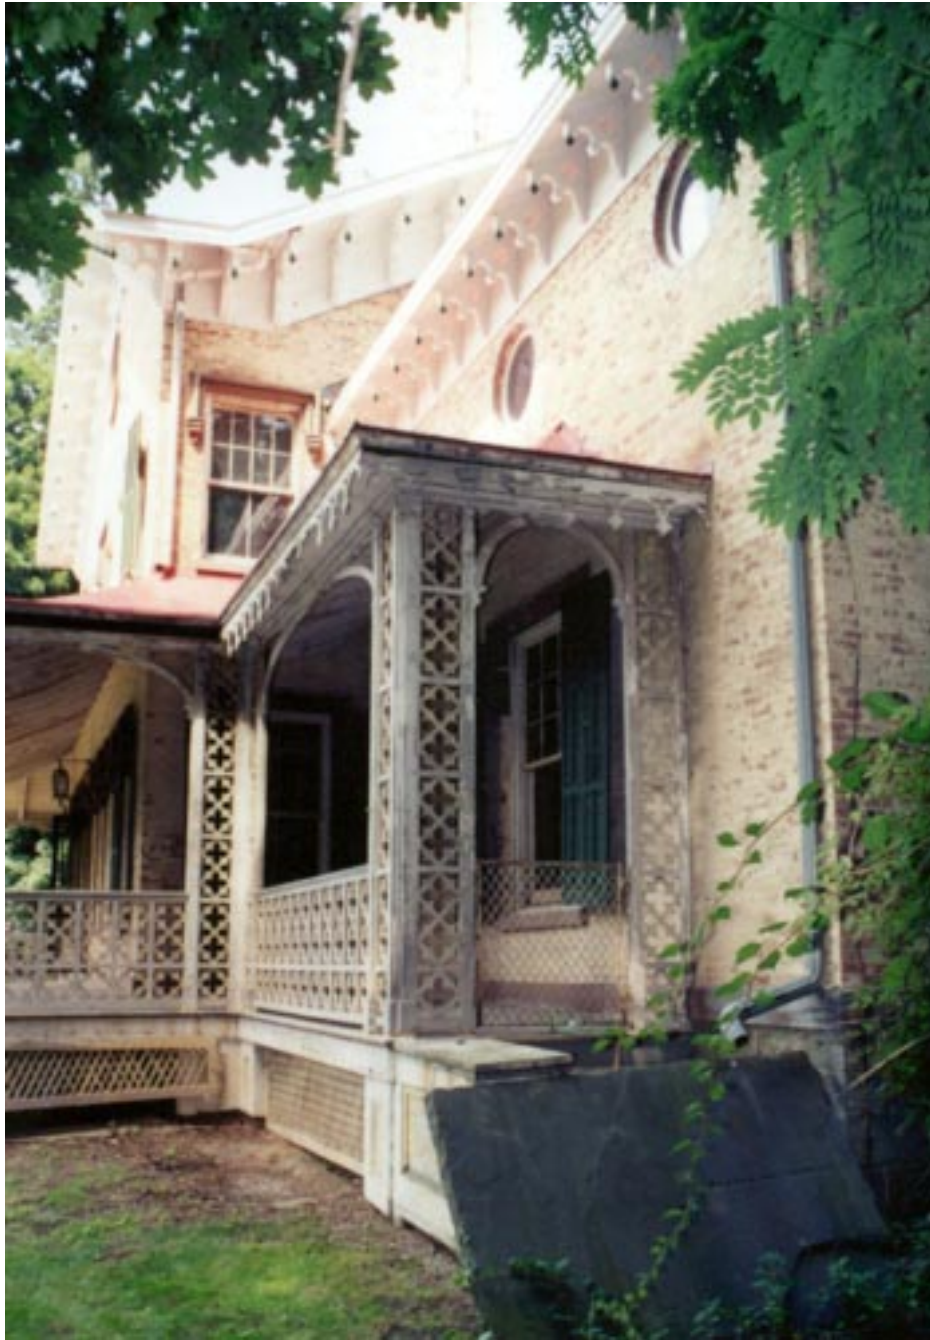
West verandah with leaning bluestone paving slab. The delicate Gothic fretwork is reminiscent of A.J. Davis' work in the area adding a graceful and light quality to the otherwise solid masonry house block. The verandah should be restored meticulously as it is possibly the most significant feature on the exterior of the house. The metal roof, the pedestals flanking the steps, and the latticework beneath the deck should be restored as well..

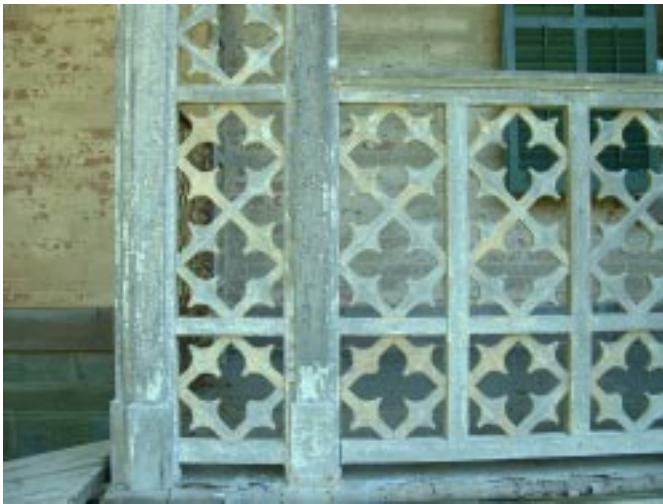
Details of the intricate fretwork and drop finials on west verandah. The fretwork is in danger of further deterioration should it not be addressed in the immediate future.

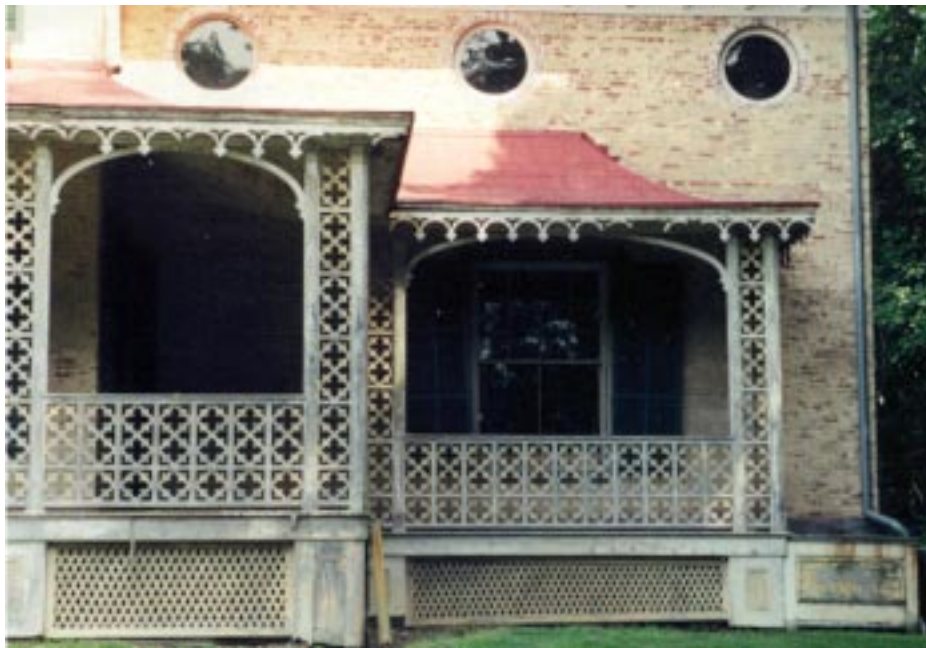
The delicate fretwork of the west verandah is in desperate need of restoration. The drop finial tracery is missing in some areas and should be replaced.

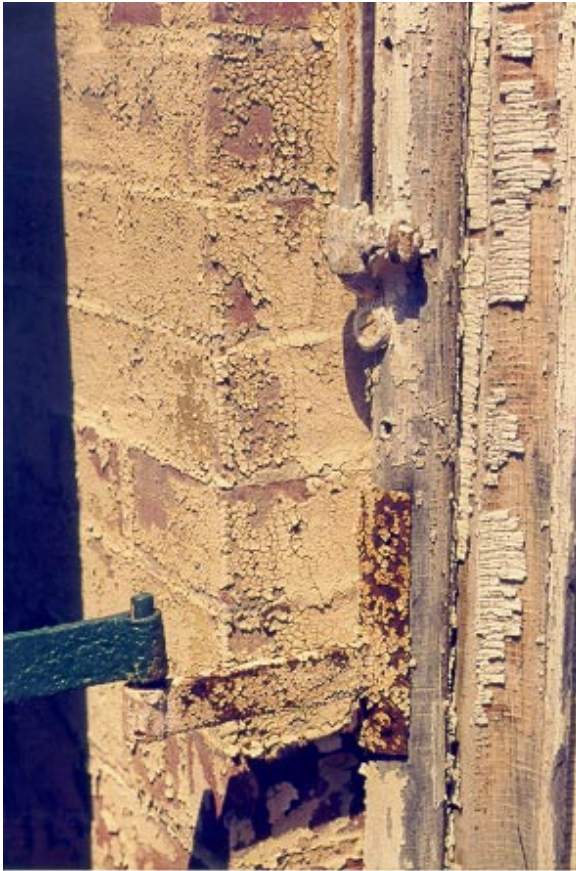
Detail of a window opening shows paint failure as well as shutter hardware that must be restored.

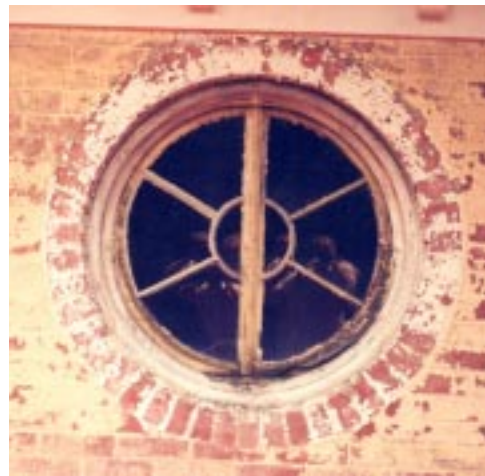
Circular window illustrates typical deterioration of the frame and sash elements in many of the existing windows.

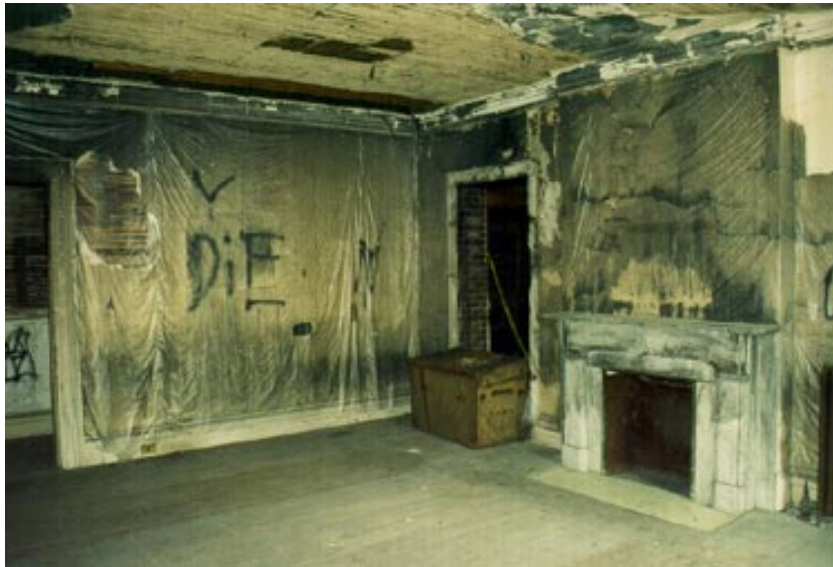
Mrs. Kinkead's morning room on the second floor in the southwest corner of the main block. The plaster on the ceiling and walls is almost entirely missing and should be replaced using the blueboard system.

Fortunately, most of the plaster within the house is simple flat plaster, which is easily repaired. There are two recommended ways of performing the repair work to the ceilings. The first is to simply remove large portions of un-keyed plaster, install wire lath over the existing wood lath (if it is found that the nails are loose in the existing lath the lath must be removed also) and install new plaster at these locations. The second method is to remove the plaster and install “blue-board”, which is a type of gypsum drywall covered with a skim coat of plaster. The “blue-board” system is less costly than conventional plaster. Since many rooms on the second floor have lost their plaster ceilings almost entirely, the prudent and recommended approach is to replace them with the “blue-board” system, and repair the mostly intact ceilings on the first floor with conventional plastering methods. Of course, the ceilings on the first floor that are entirely missing (such as in the ceiling in the Dining Room) should be replaced with the “blue-board” system. It is assumed that the modern service rooms (toilets, etc.) within the service wing will be finished with drywall.

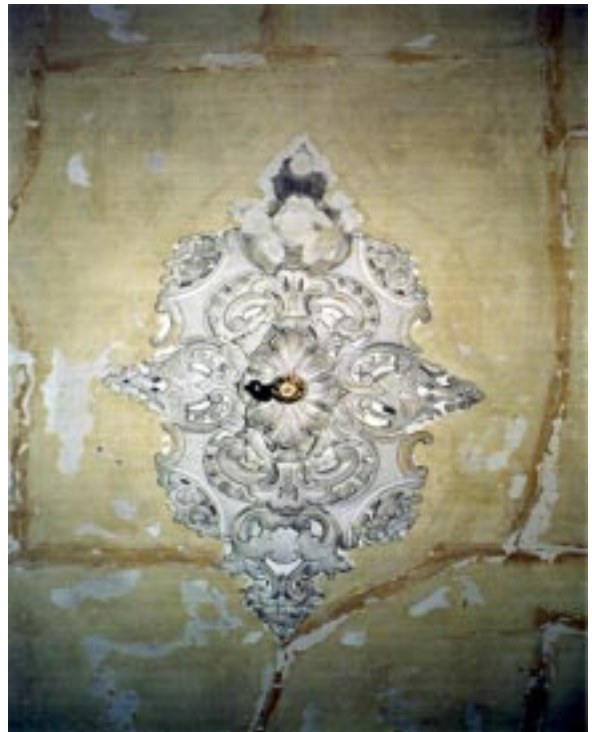
Plaster medallion in Grandparents' Parlor. Note the pervasive cracks in the ceiling due to temperature and humidity changes.

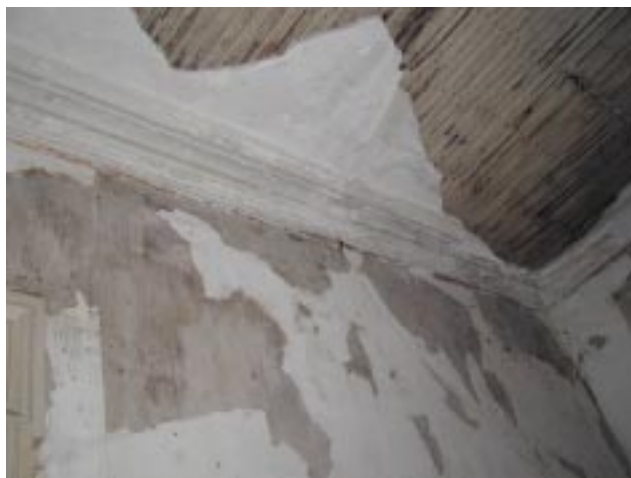
Run plaster molding in need of repair in Mrs. Kinkead's rooms on the second floor. The ceiling should be replaced using the blue-board system and the run moldings repaired in-situ.

All run moldings will require in-situ repairs or replacement using conventional plastering methods. The run molding around the skylight at the second floor requires complete replacement. The profile of the small surviving portion may be used to replicate the remainder of the molding.

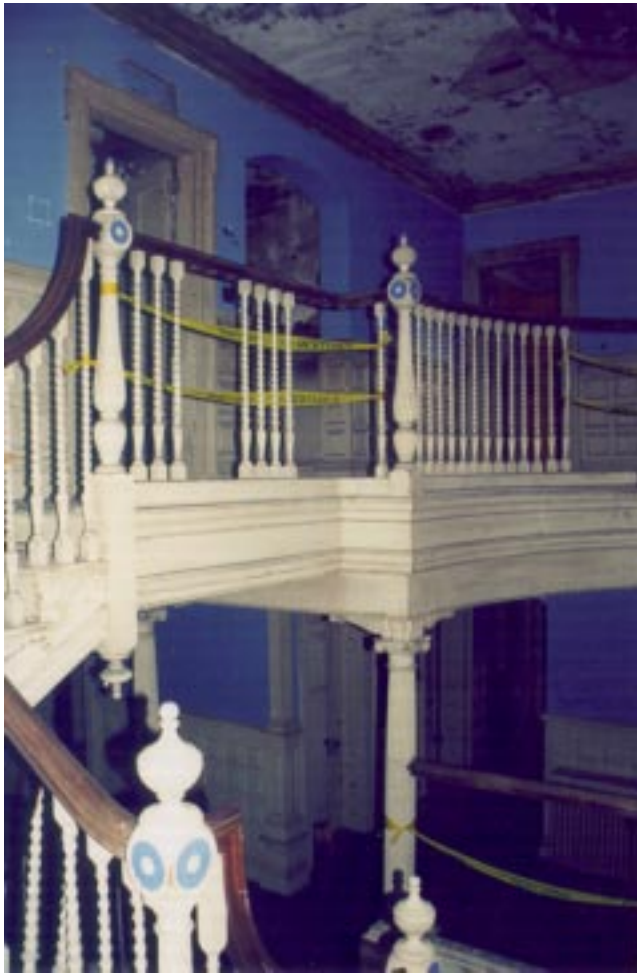
Missing balusters mar the sweep of the once-grand Colonial Revival staircase. Delicately turned, twisted balusters and intermediate newel posts punctuate the route of the four-run staircase. Missing elements should be replaced during the conservation efforts.

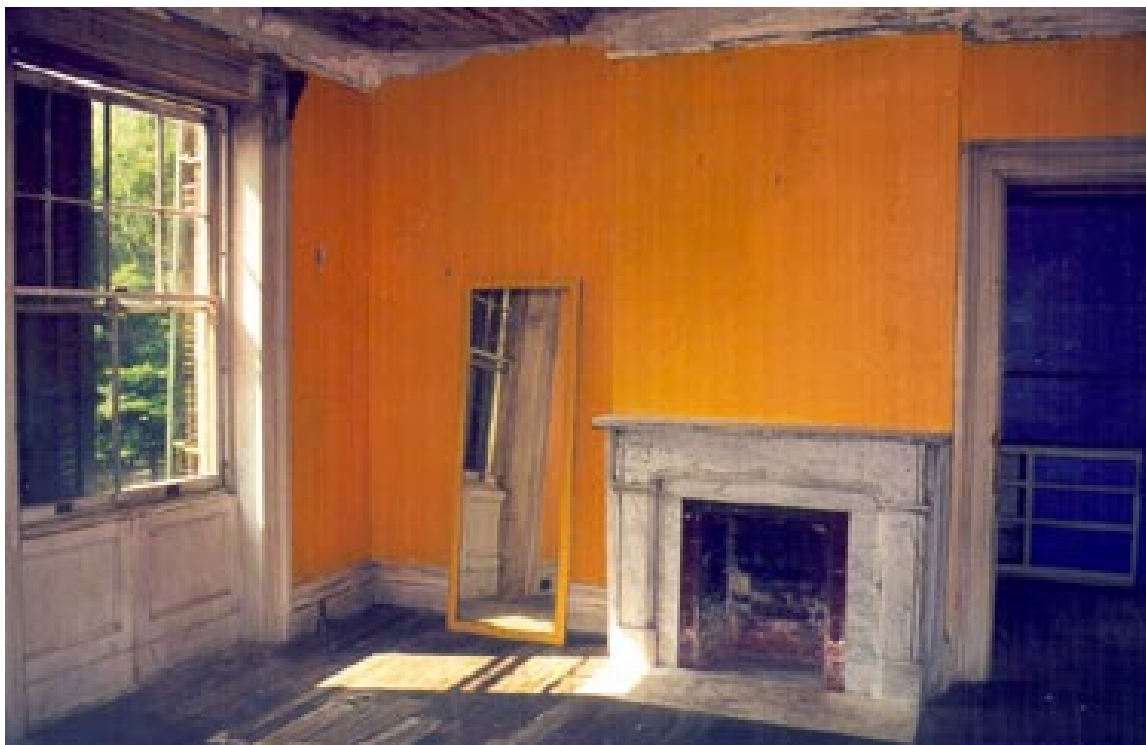
Fine woodwork and plasterwork can be found in most rooms in the house. The example in the photograph is from Mrs. Kinkead's Bedroom on the second floor off the Upper Stair Hall. Note the marble mantelpiece and wood panels beneath the windows. The ceiling was heavily damaged as are the run plaster moldings.

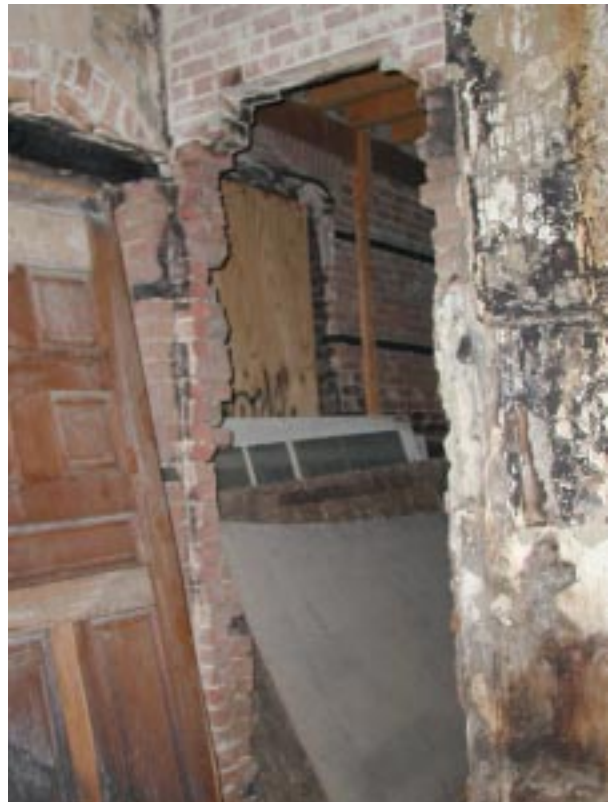
Opening cut through the back wall of Kitchen into the Laundry must be stabilized using either a steel lintel or a brick arch as in the other masonry openings in the house.

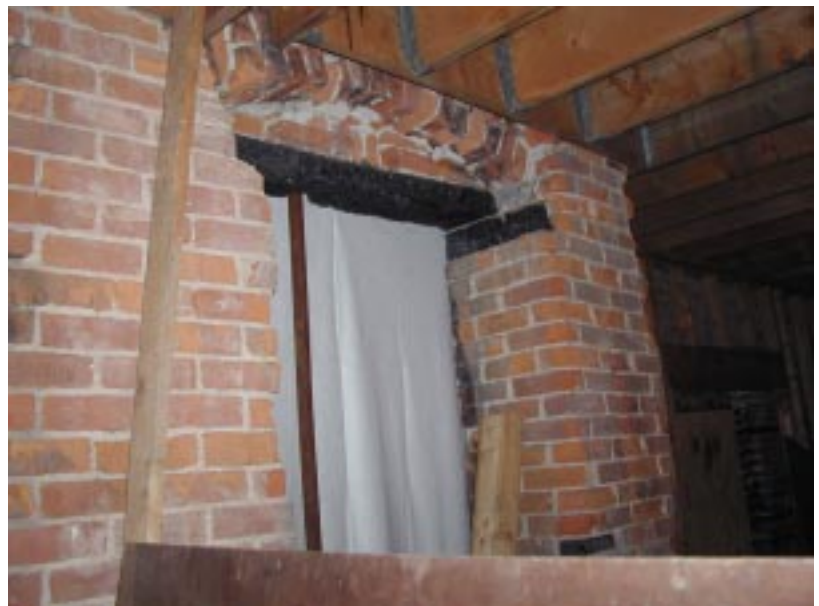
The interior wall of Kitchen shows fire damage the the wood members and the masonry techniques used in the 19th century.

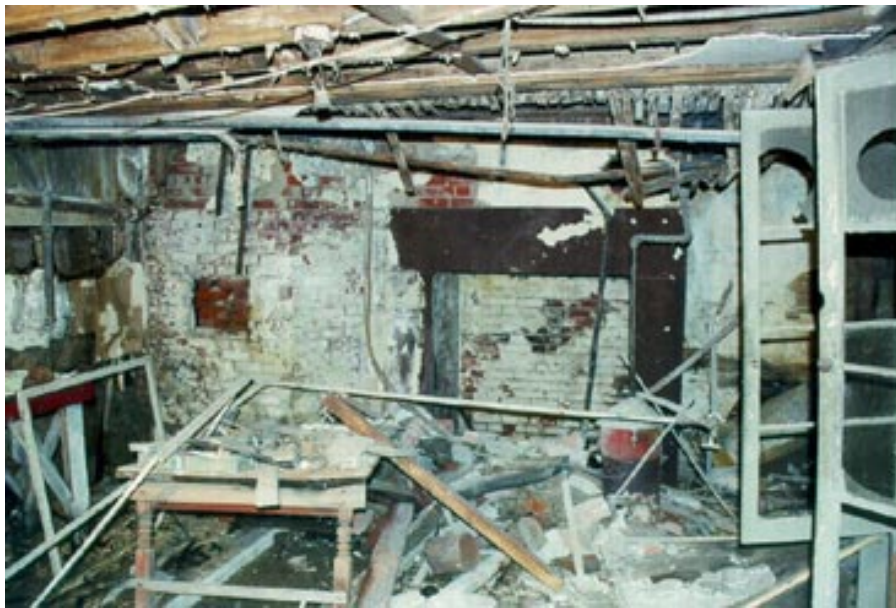
Basement kitchen is severely damaged from water damage during the 1985 fire. Note the kitchen hearth, beehive oven and cabinets. The area should be cleaned and historic features retained.
