Problems and Recommendations for Repair

Exterior

Interior

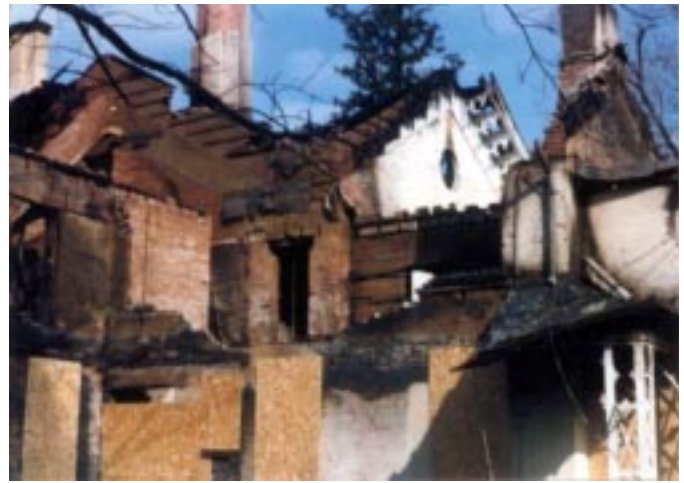
The roofs were destroyed in the 1985 fire. They were rebuilt using photographs and recollections as construction guides.

The composition shingles on the main roof of the house appear to be in good condition, yet the installation was a temporary measure to protect the building as exhibited by the use of very few nails to anchor the shingles. High winds readily blow off the shingles leaving the interior open to the elements. While it may be desirable to

eventually replace the existing asphalt roof shingles with wood shingles (if it is found that wood shingles were, indeed, the original material on these roofs), funding priorities and its relatively good condition does not warrant its replacement at this time. The roof should, however, be repaired to the degree where it keeps water infiltration to a minimum. Flashings around the chimneys and roof intersections should be replaced and the reglets cleaned and reused. The reglet cuts should be studied for evidence of historic flashing as in 1850 flashing was not applied using reglets.

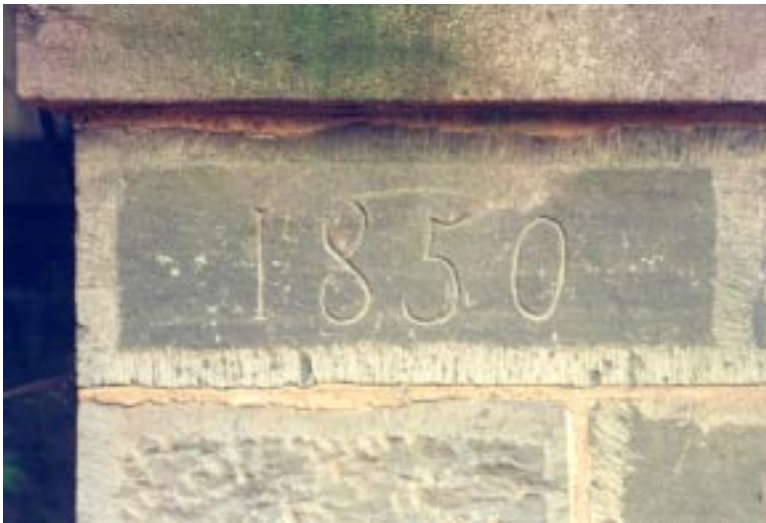
Date of original construction on cornerstone at northwest corner of house. Note the drafted edge fieldstone used for the foundation and cut brownstone watertable course. Minimal repair is needed in most areas.

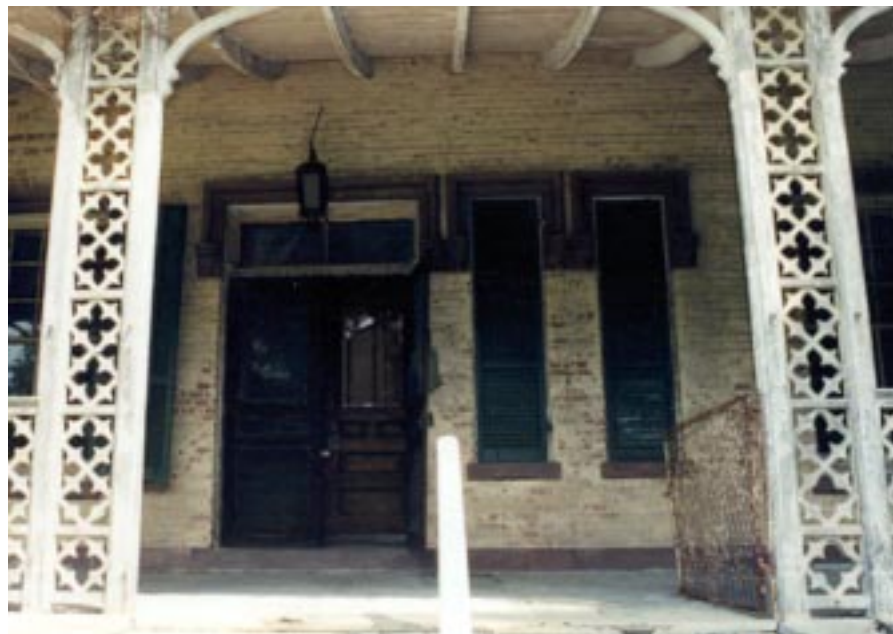
The main entrance doors of house were once flanked by windows placed symmetrically on the facade. The north window and door were relocated during 1891 renovations to better serve the interior house plan. The location is an excellent example of 19th century brick masonry repair and should be emulated in the other areas of the restoration project.

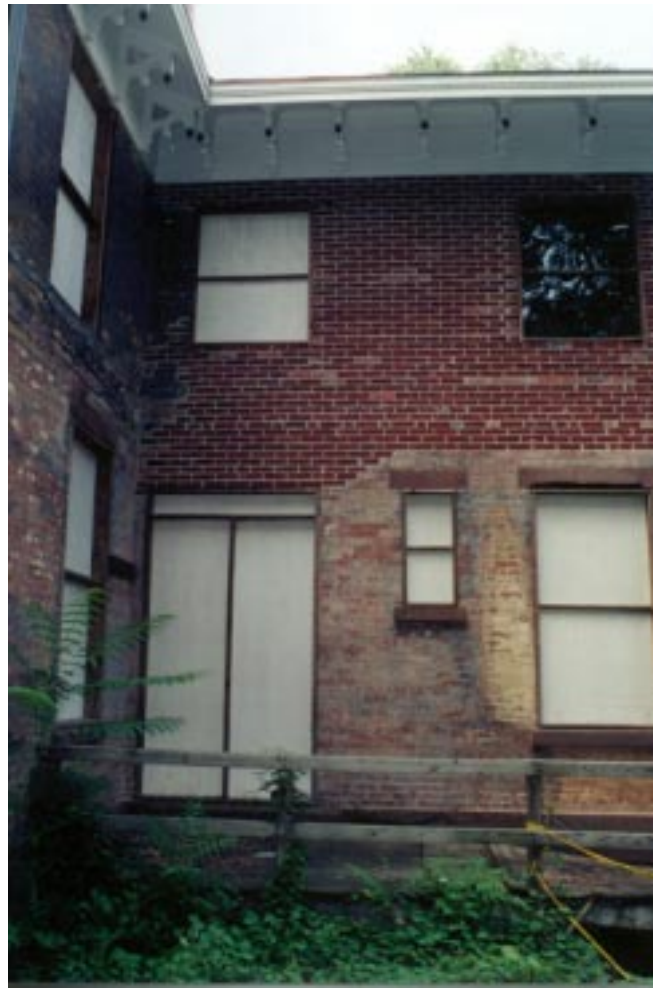
The brickwork at the intersection of the service wing and south wing was reconstructed after the 1985 fire. Note the difference in the bricks used, the position of the door and the lack of brownstone lintels on the second floor of the wing.

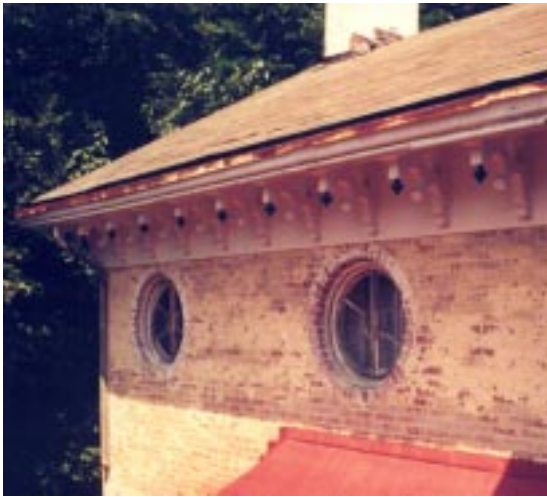
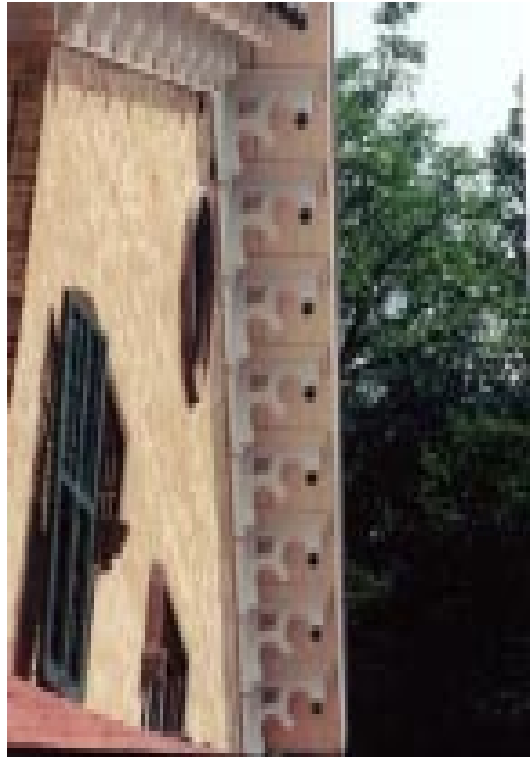
The main cornice was restored in the 1990s and is still in good condition. Above: cornice of main block; left: north wing.

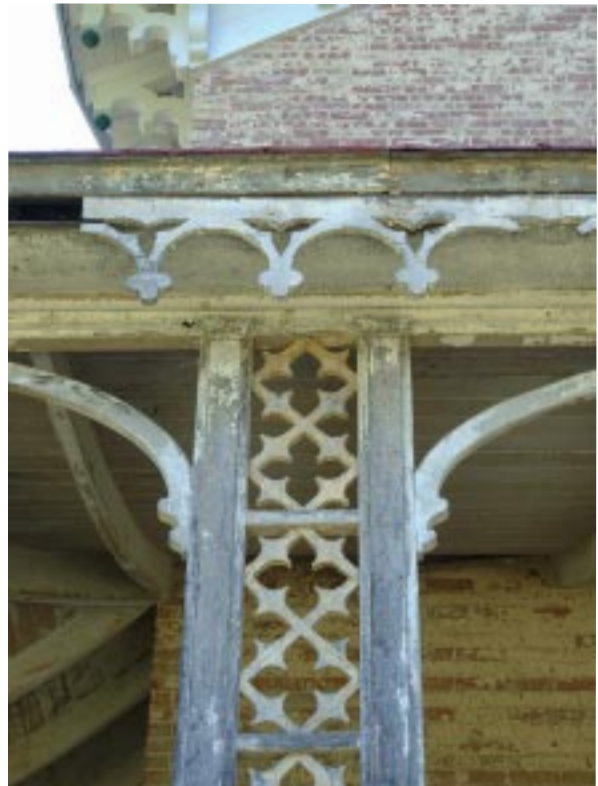
Considering the fact that the west verandah has been virtually neglected for the past several decades, much of the original fabric survives and is in relatively good condition. The condition of the verandah can be attributed to the dense wood employed in its construction, as well as the watertight roof. The floor of the verandah was protected by a layer of painted canvas, which is now well beyond its useful life. The present canvas found on the verandah floor no doubt replaced a similar earlier canvas. While it is uncertain as to whether the earlier canvas dates to the original construction of the porch, it was certainly very early. The absence of paint beneath the canvas floor covering lends credence to the likelihood that a canvas floor covering always protected the deck boards of the verandah.

Although the condition of the verandah is surprisingly good, there is no question that it should be restored as soon as possible to prevent a permanent loss of much of the original fabric. The delicate woodwork on the west verandah is now without much of its protective paint, and parts of the delicate dropped-finial tracery around the eaves is missing. Immediate restoration efforts should include repairing or reconstructing the tracery and the brick piers below the verandah, repair to the structural armature beneath the floor, reinstatement of missing elements such as steps and pedestal walls flanking the steps (See historic photo of Jennie and Elise on the front porch for detailed evidence of the cheek walls.), and stripping and repainting the entire verandah. In addition, a lattice panel from the south end of the verandah was inadvertently installed on the north end. The panels should be repaired and installed in their proper location. The restoration of the verandah must also include the reinstatement of the painted canvas floor covering and the reinstallation of the large bluestone slabs at the base of the north and south steps.

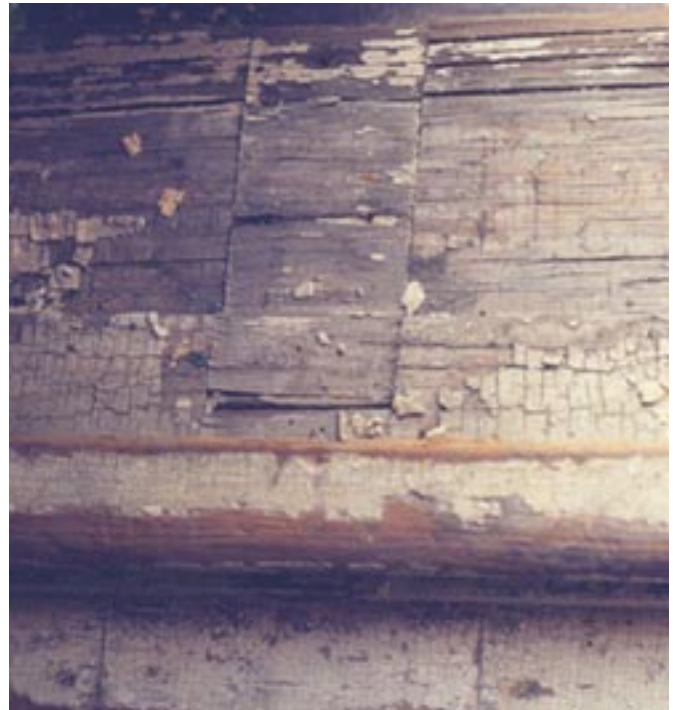
Dutchman repair in the sill of the drawing room window shows the location for a mullion that divided the sash doors in the original design of Maple Grove.

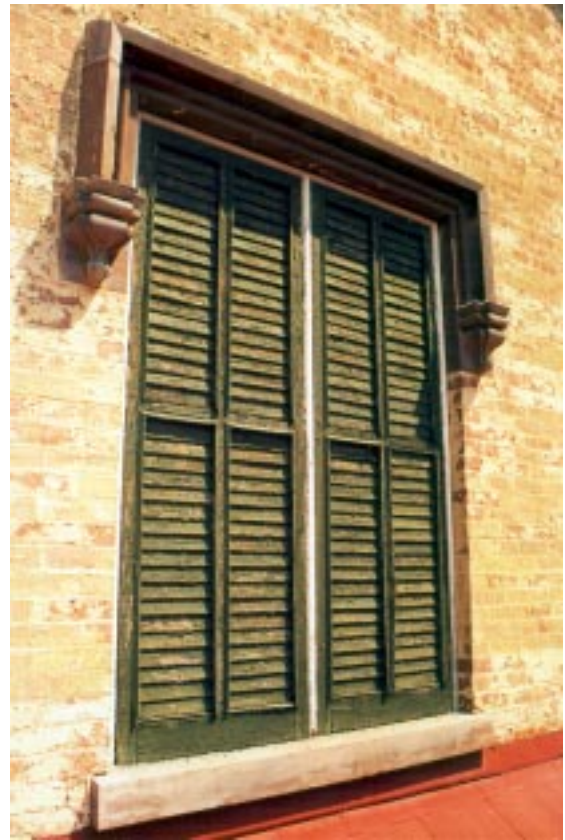
The blind window on the second floor of the west facade shows the center mullion that divided the original paired double-hung windows. Similar label molds are found on the north and south facades.

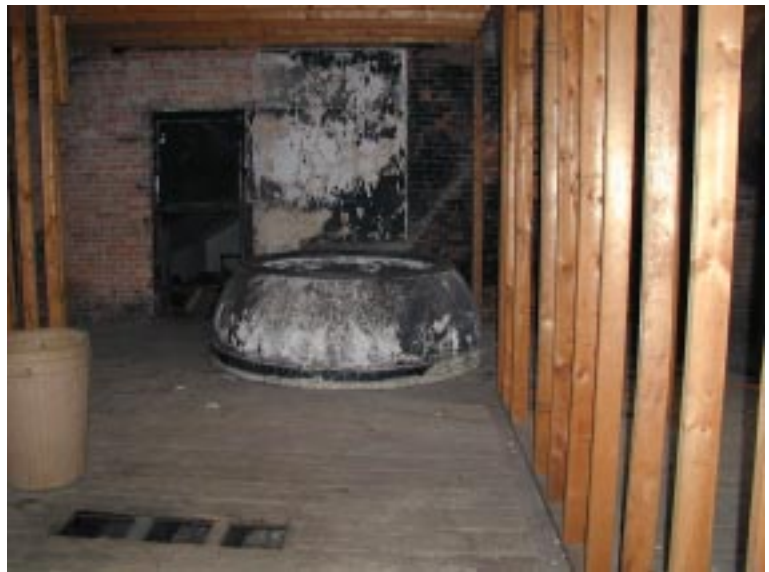
Structure of laylight in attic of main block. A skylight is said to have been located above it to allow daylight to penetrate into the stairwell.

Local lore recalls a skylight in the northeast slope of the main roof that provided daylight for the laylight in the Stair Hall. As the roof of the main block was severely damaged during the 1985 fire, no evidence remains as proof of its existence. The window added in 1891 reduced the necessity for the skylight, but if funds allow its reconstruction along with the laylight, much of the quality of the Stair Hall would be regained. The skylight was, more than likely, built of wood and its replacement should be in keeping with the character of the house. The central roundel of opalescent glass is all that survives of the laylight. A photograph of the southeast porch shows another skylight over the rooms in the south wing-- this might be a good model for the new skylight on the main block of the house.

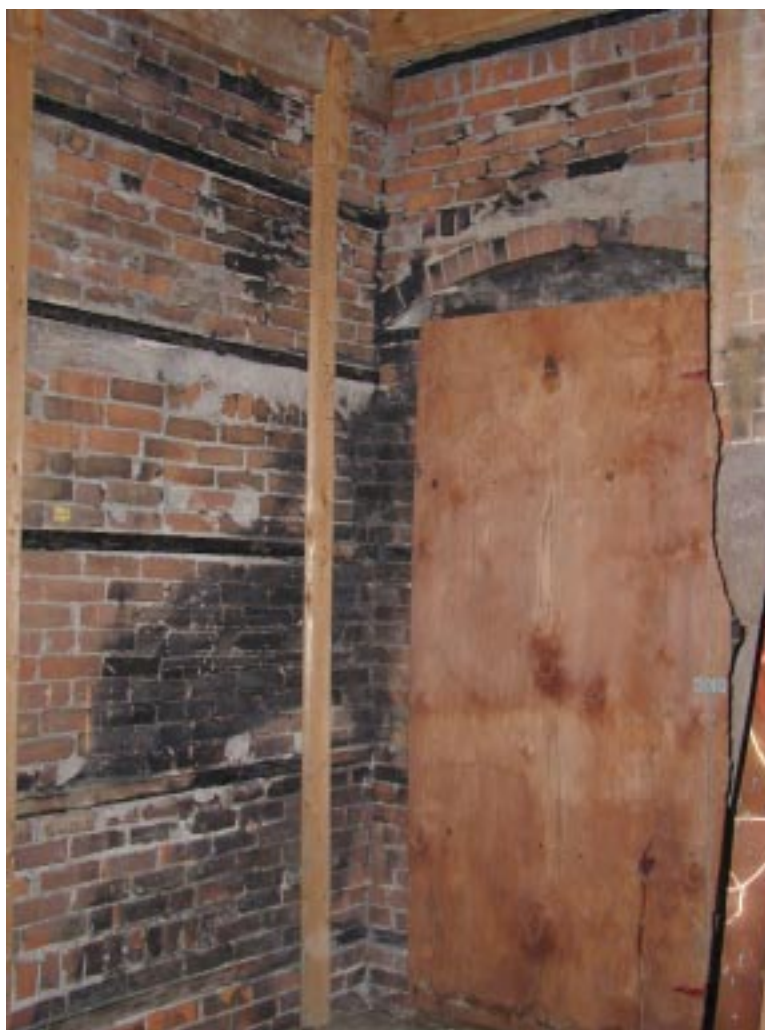
The brickwork of the kitchen interior is interrupted by wood nailers used to affix shelving or paneling to the masonry surfaces. The opening dates from the 1850 plan of the house, which led to the east yard. The opening was sealed up during the 1891 alterations when a new opening into the Laundry was made. The photograph is illustrative of the basic soundness of the building and the various states of disrepair.

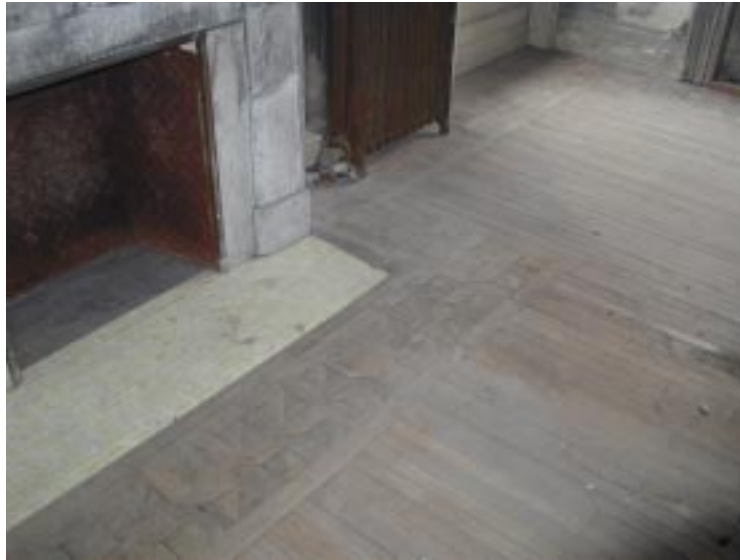
The parquet flooring in Mrs. Kinkhead's Morning Room was installed in 1891 over the wider softwood floors. The hearth is at the level of the original floor, approximately 3/4" below the narrow boards.

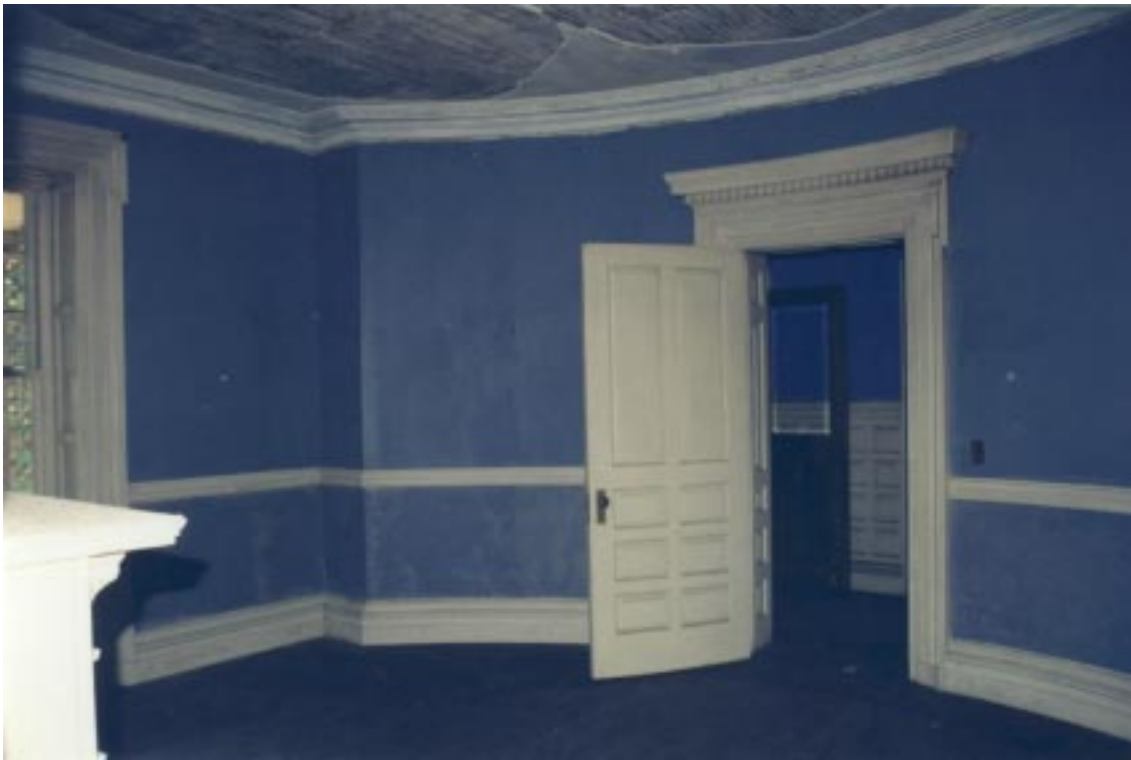
Curved bearing wall of drawing room allowed the front door to open prior to the 1891 alterations. The dog-eared architraves, baseboard molding and chair rail are Greek Revival in style, but the Colonial Revival cornice on the door was added later.

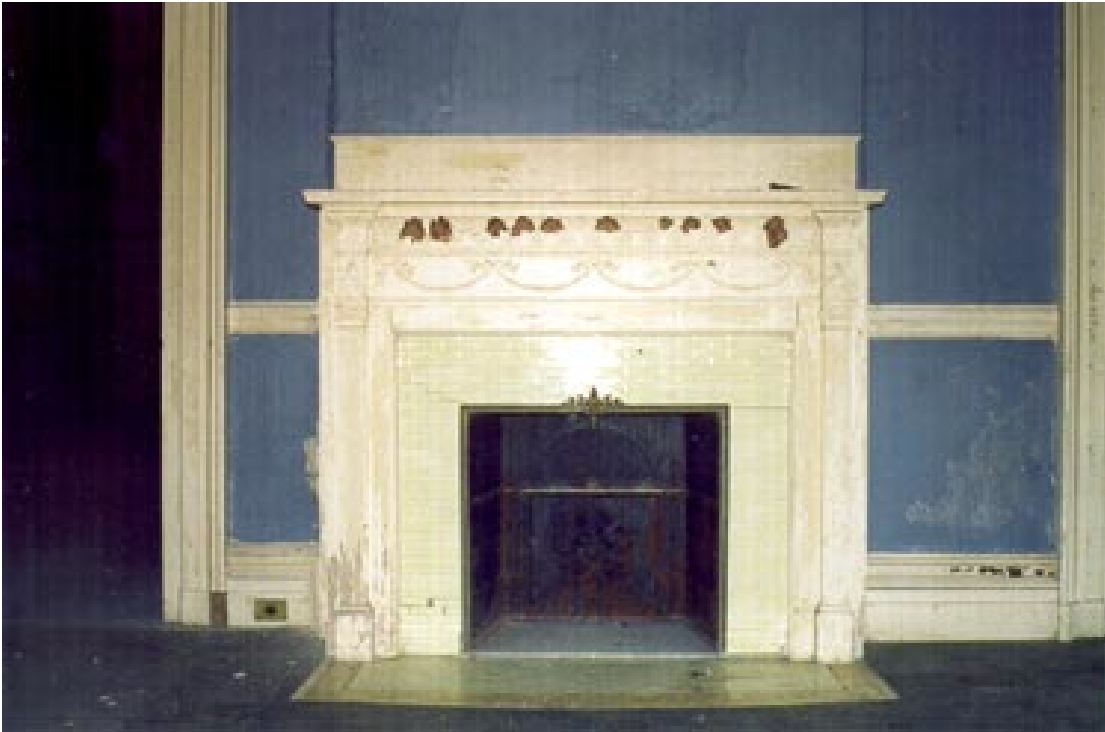
Drawing Room fireplace and mantle are excellent examples of Colonial Revival Style.

The mantelpiece and tile hearth in the Drawing Room date from the late 19th century and several loose tiles must be reset around the firebox. The remainder of the fireplace is in excellent condition. Similar repairs are required at the large Library Colonial Revival fireplace, which is otherwise in excellent condition.

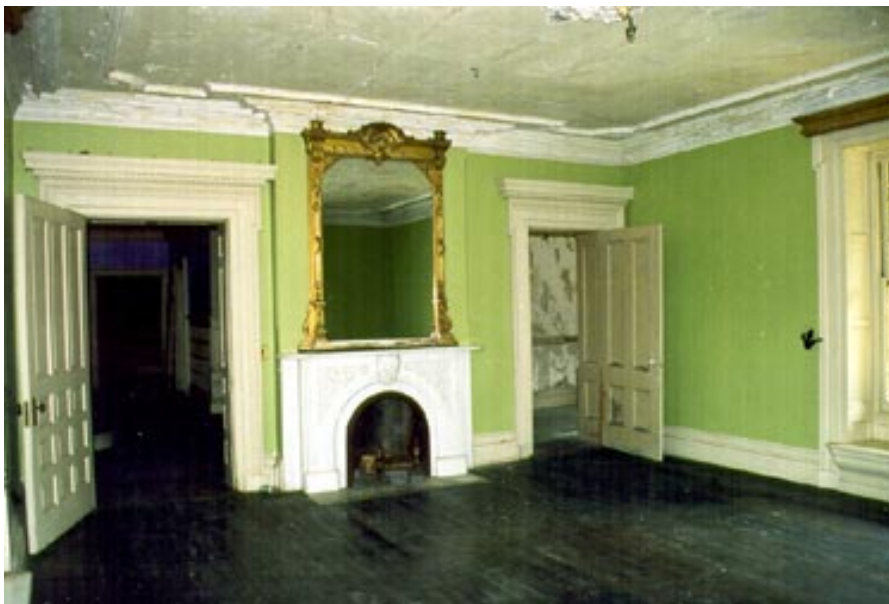
Grandparents' Parlor was once quite lush in its decoration. Historic photographs reveal rich floral wallpaper and dark-stained crown moldings. The woodwork has been painted, but remains in good condition.

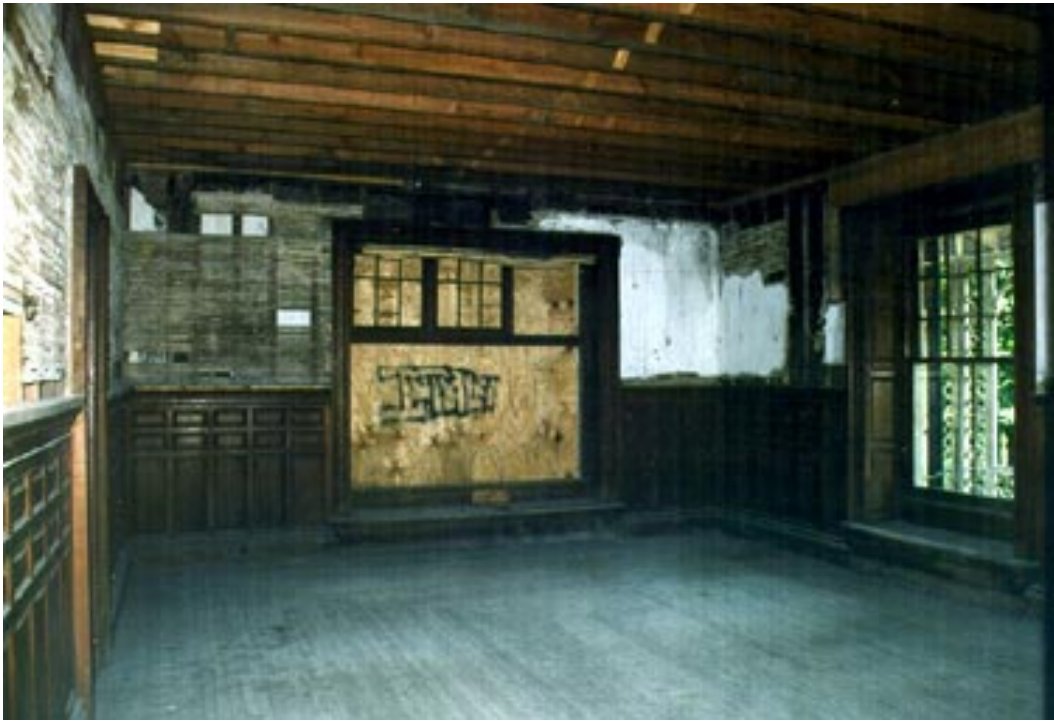
The Dining Room paneling is quite fine and should be restored along with the plaster ceiling and wallpapered walls.

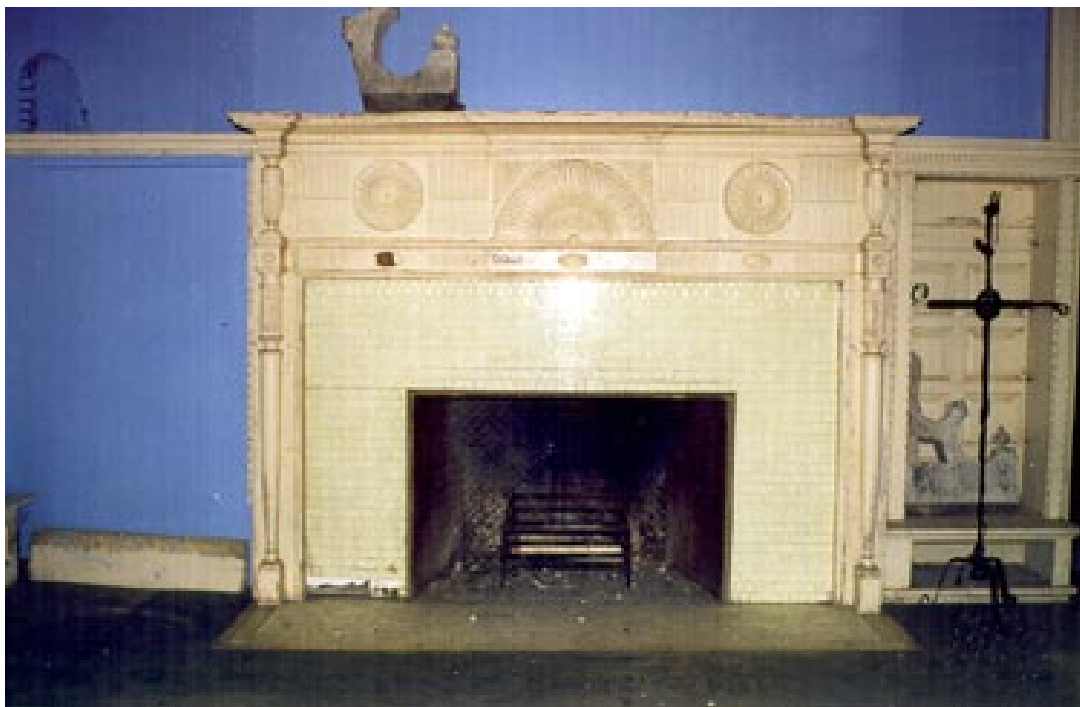
The Colonial Revival fireplace in Library designed by William R. Walker & Sons Architects. The delicate details recall the Adam style popular in the late 18th century. In 1850, the Kitchen was accessed to the left of the fireplace. In 1891, the opening was blocked off and library shelving installed.

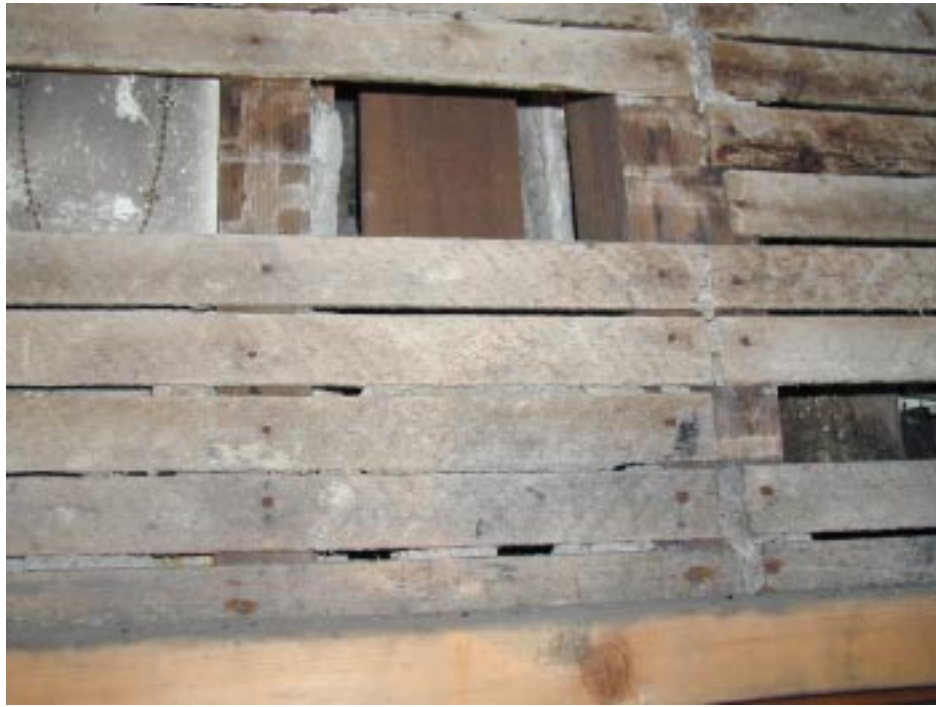
Location of wall change in Dining Room. The wallpaper to the left is quite close to the masonry wall, while a second wallpaper to the right is just behind the 1891 lath. The jog in the wall reflects the changes prior to the 1891 alterations.

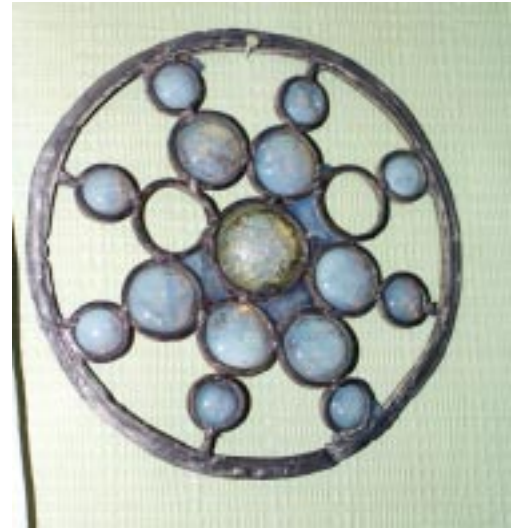
The opalescent glass center of the laylight was in the keeping of Gretchen Rendes. The new laylight should be designed around the remaining piece.

Skylight and laylight: It is believed that the plaster skylight well over the present day stair remains from the 1850s construction period. The original plan included earlier in the report illustrates its juxtaposition to a possible historic stair layout. The skylight would have provided some light to the original stair. Yet even with this top light, the lack of window openings onto the original stairway at both floors would have made for the dark conditions mentioned to the Kinkead daughters by their aunt (recalled by Elise Kinkead in her conversation with Kenneth Toole. See Bibliography for reference). If her recollection is accurate, the skylight was retained during the late 19th century remodeling and a new leaded-glass laylight was created using fragments of the 1850s leaded-glass laylight. It is recommended that the leaded-glass laylight be reinstated during any major restoration activity.

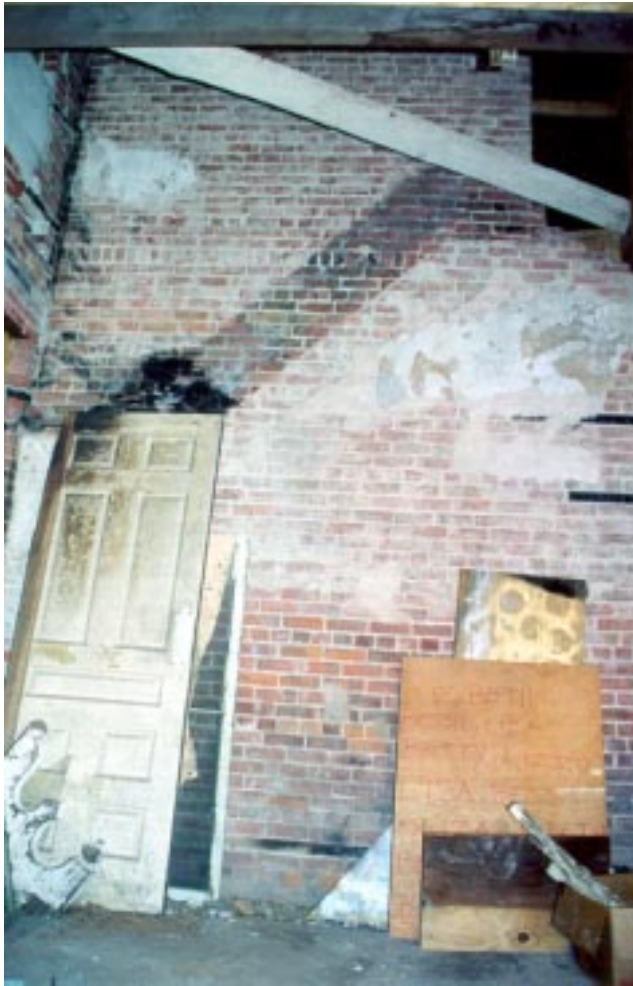
Ghost of the service stair in the rear entry hall between the Kitchen and Butler's Pantry. Note its steepness. The passage to the second floor chamber, "George's Bedroom", is visible at the upper right. The service stair was destroyed in the 1985 fire that left much of the south end of Maple Grove severely damaged. Many doors and pieces of the structure may be found stored in the basement of the house.

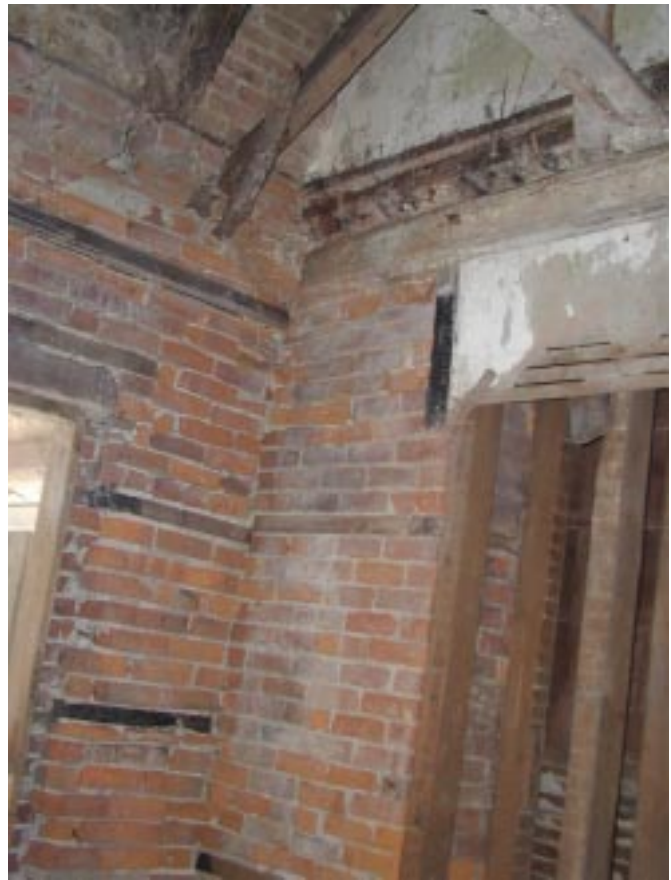
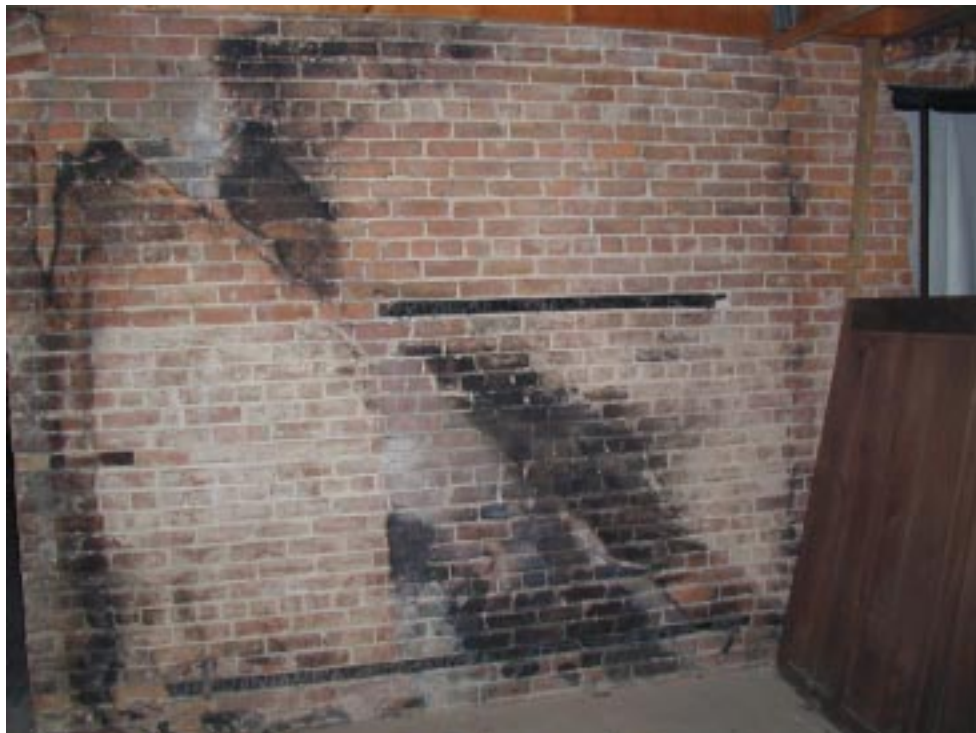
Ghost of the attic stair in the south wing. Nailers, the pieces of wood inserted between the bricks, were used to fasten elements like baseboard molding, paneling and shelves to plastered masonry walls. In the 19th century, the plaster was applied directly to the brickwork.
